DEPARTMENT OF TRANSPORTATION

Quality Assurance and Source Inspection

Contract #: 04-0120F4Cty: SF/ALA Rte: 80 PM: 13.2/13.9File #: 1.28**WELDING INSPECTION REPORT****Resident Engineer:** Casey, William**Address:** 333 Burma Road**City:** Oakland, CA 94607**Report No:** WIR-028043**Date Inspected:** 23-Jul-2012**Project Name:** SAS Superstructure**OSM Arrival Time:** 700**Prime Contractor:** American Bridge/Fluor Enterprises, a JV**OSM Departure Time:** 1930**Contractor:** American Bridge/Fluor Enterprises, a JV**Location:** Job Site**CWI Name:** As noted below**CWI Present:** Yes No**Inspected CWI report:** Yes No N/A**Rod Oven in Use:** Yes No N/A**Electrode to specification:** Yes No N/A**Weld Procedures Followed:** Yes No N/A**Qualified Welders:** Yes No N/A**Verified Joint Fit-up:** Yes No N/A**Approved Drawings:** Yes No N/A**Approved WPS:** Yes No N/A**Delayed / Cancelled:** Yes No N/A**Bridge No:** 34-0006**Component:** SAS OBG**Summary of Items Observed:**

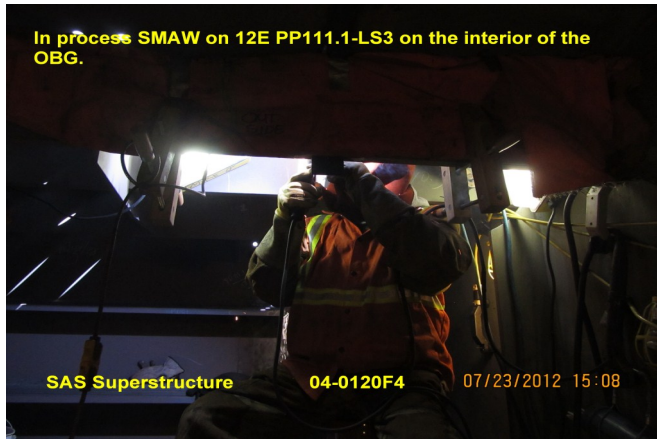
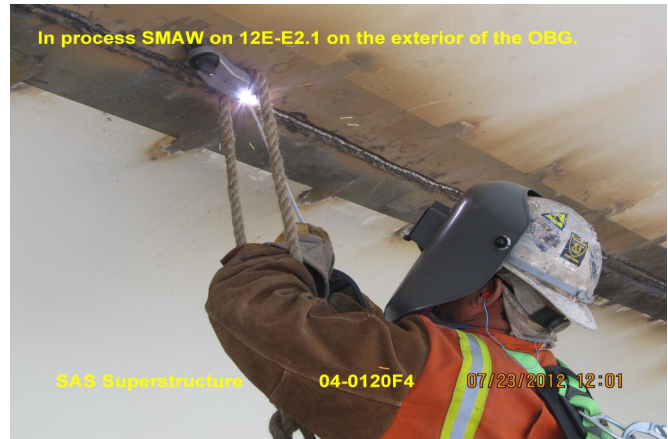
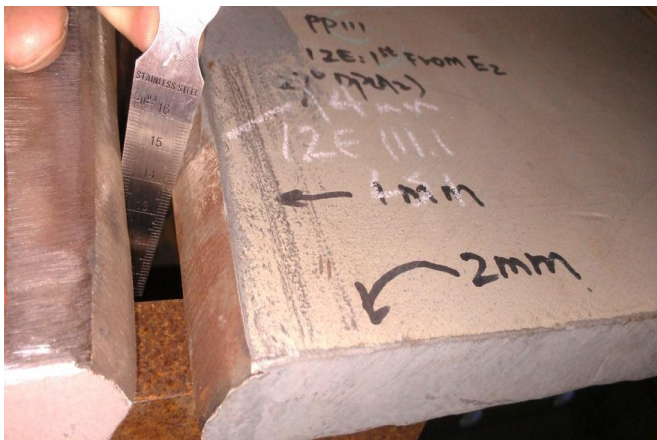
12E PP111.1-LS3 (Interior)

This QA Inspector conduction fit up operations and planar alignment measurements on the Longitudinal Stiffeners at 12E PP111.1 on the interior of the OBG. This QA Inspector observed that the Root Opening varied from 9mm to in excess of 15mm. This QA Inspector generated an Incident Report on this date and notified METS QA Lead Inspector Danny Reyes and METS QA Task Leader Bill Levell via email for review and disposition of the report due to the non-compliance with AWS D1.5-2002 - Section 3.3 - Assembly 3.3.4.2 Root openings larger than those allowed in 3.3.4.1 may be corrected by welding only with the approval of the Engineer. See attached photos for further details.
